FUEL CONTAINMENT AND DAMAGE TOLERANCE IN LARGE COMPOSITE PRIMARY AIRCRAFT STRUCTURES PHASE II -- TESTING

NASA Contract No. NAS 1-16856

April, 1985

NASA CONTRACTOR REPORT 172519

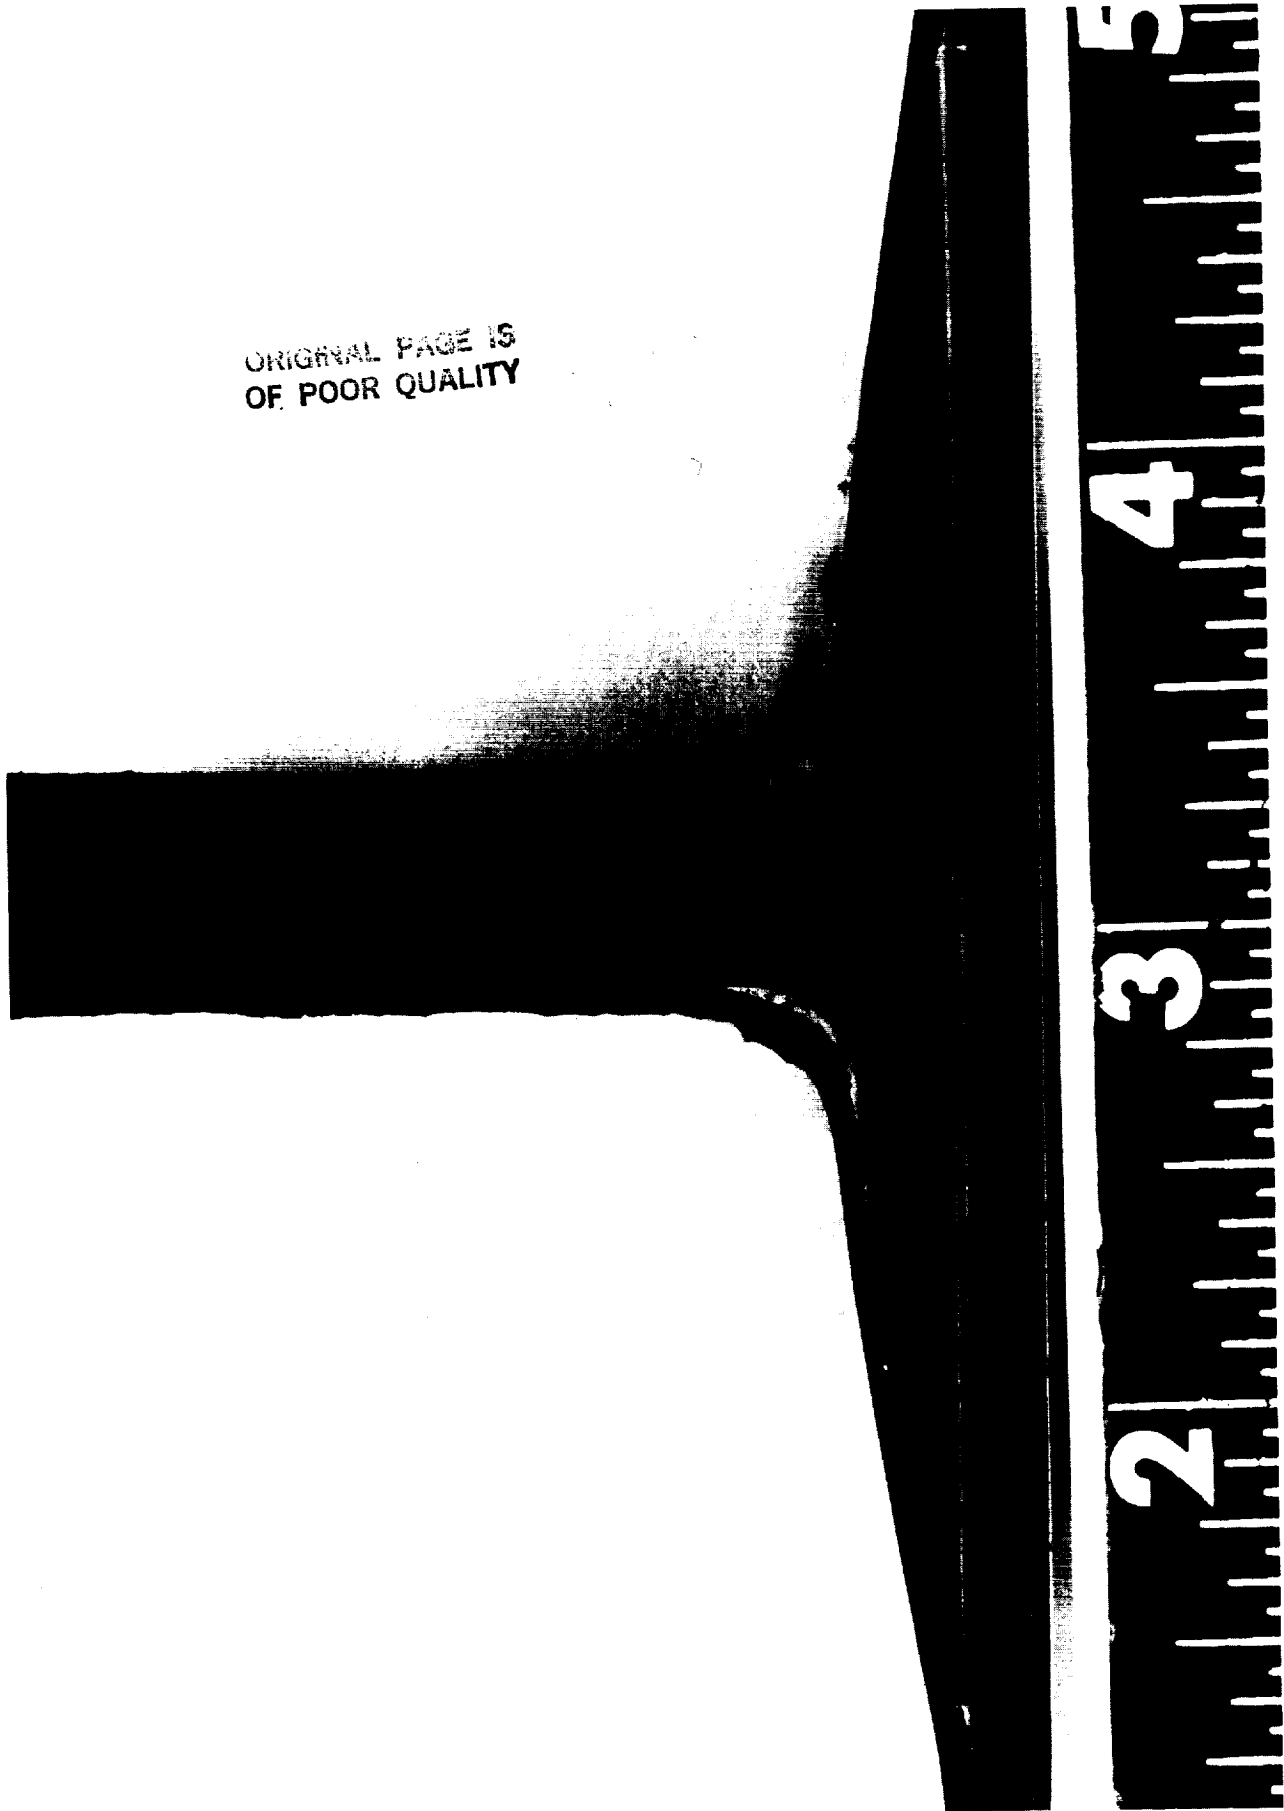
Figure 4-23: Stiffener side load specimen D2 failure.

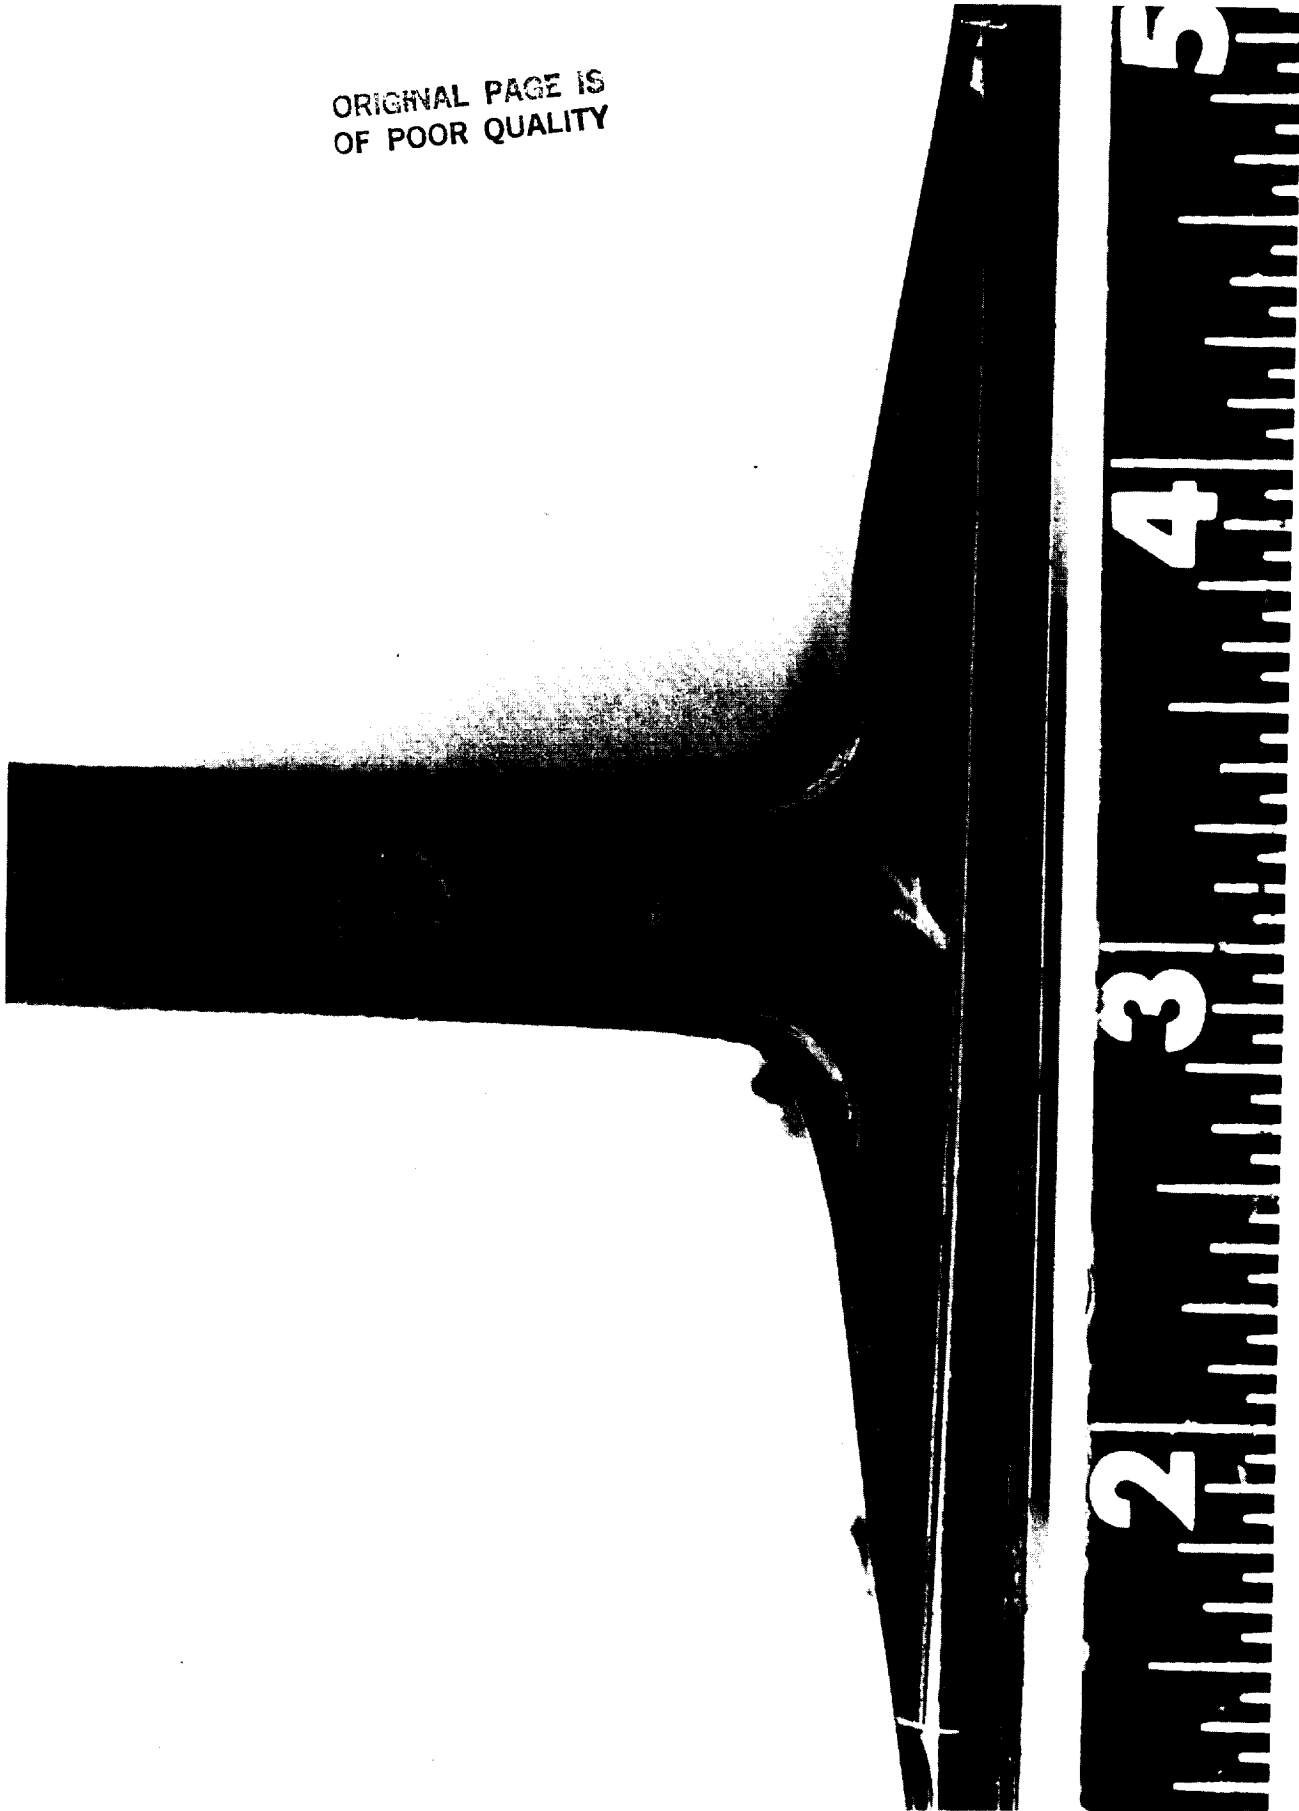
Figure 4-24: Stiffener side load specimen D3 failure.

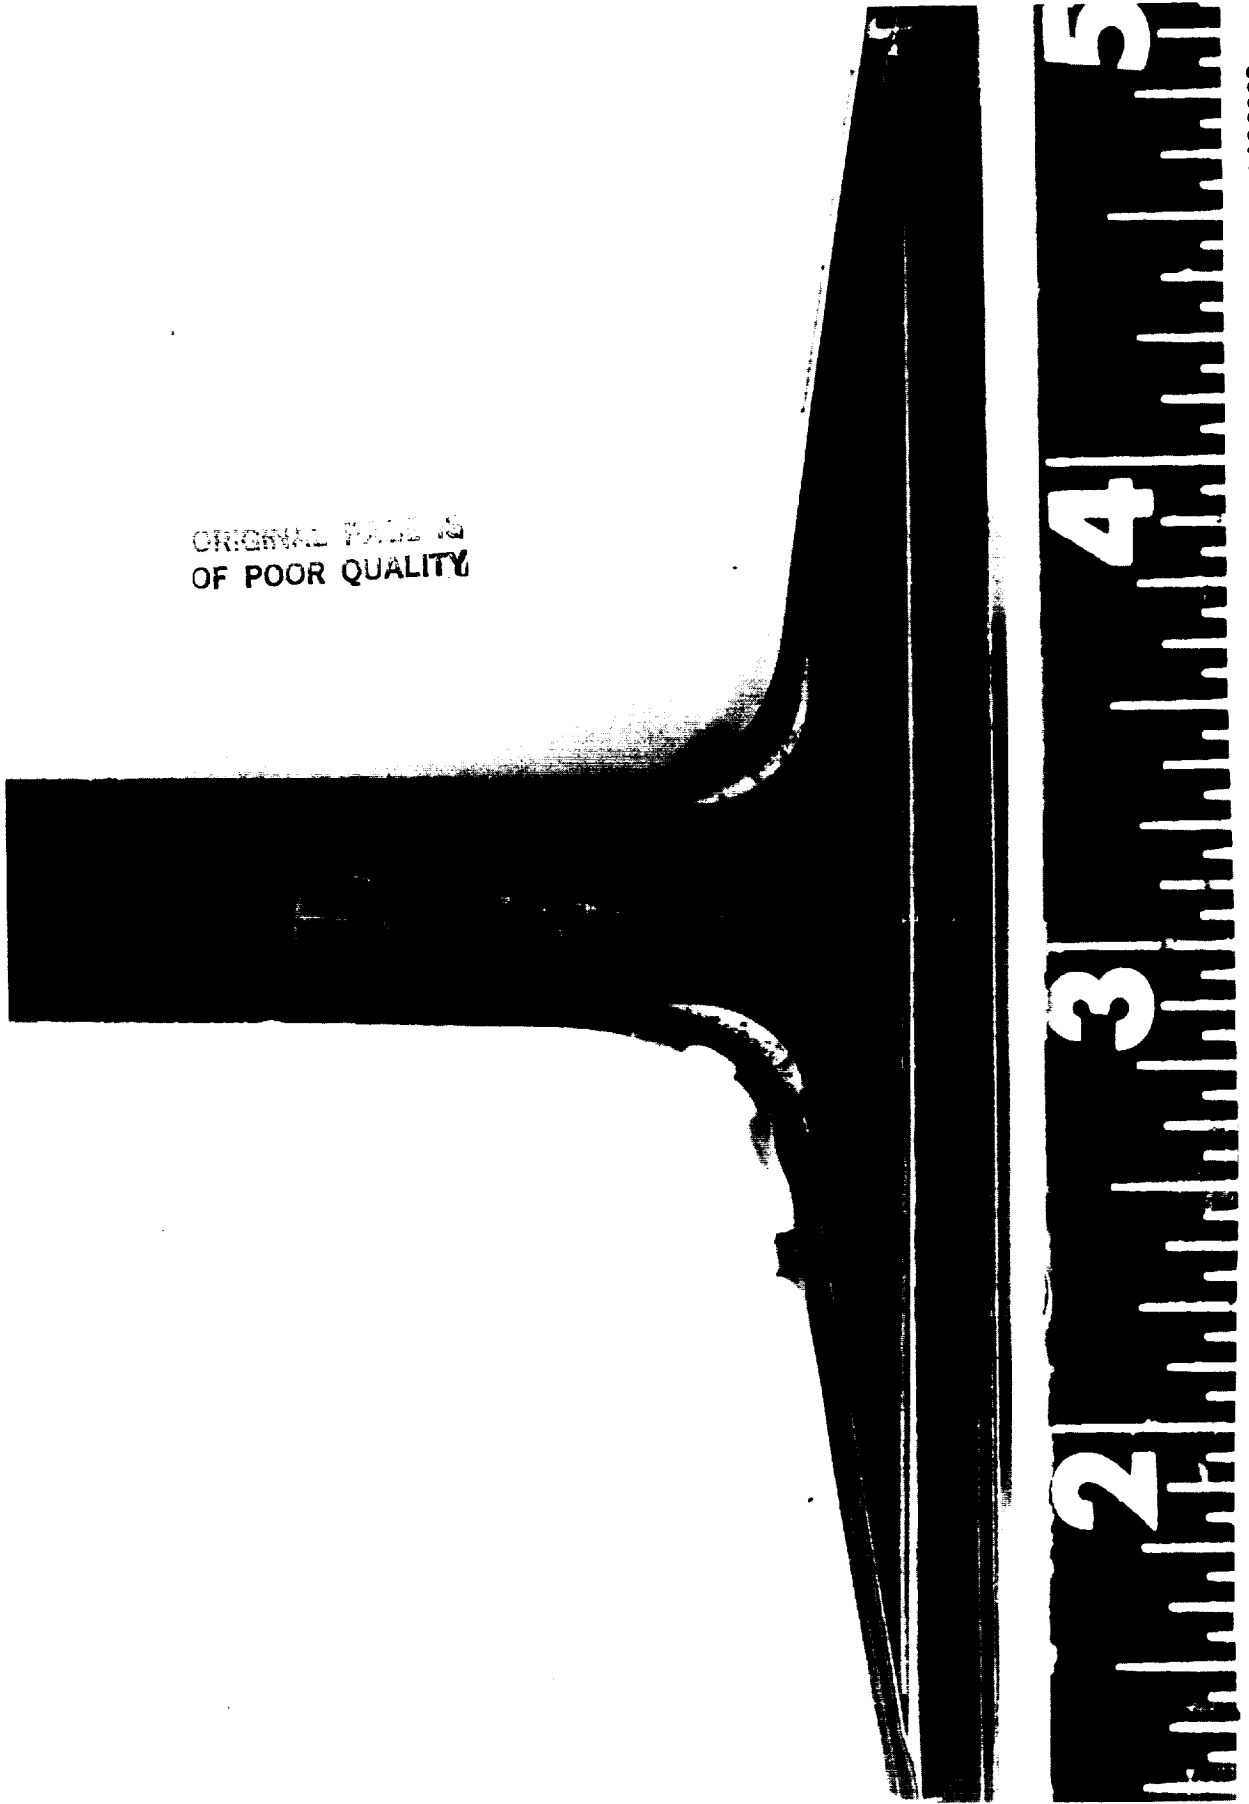
Figure 4-25: Stiffener side load specimen D4 failure.

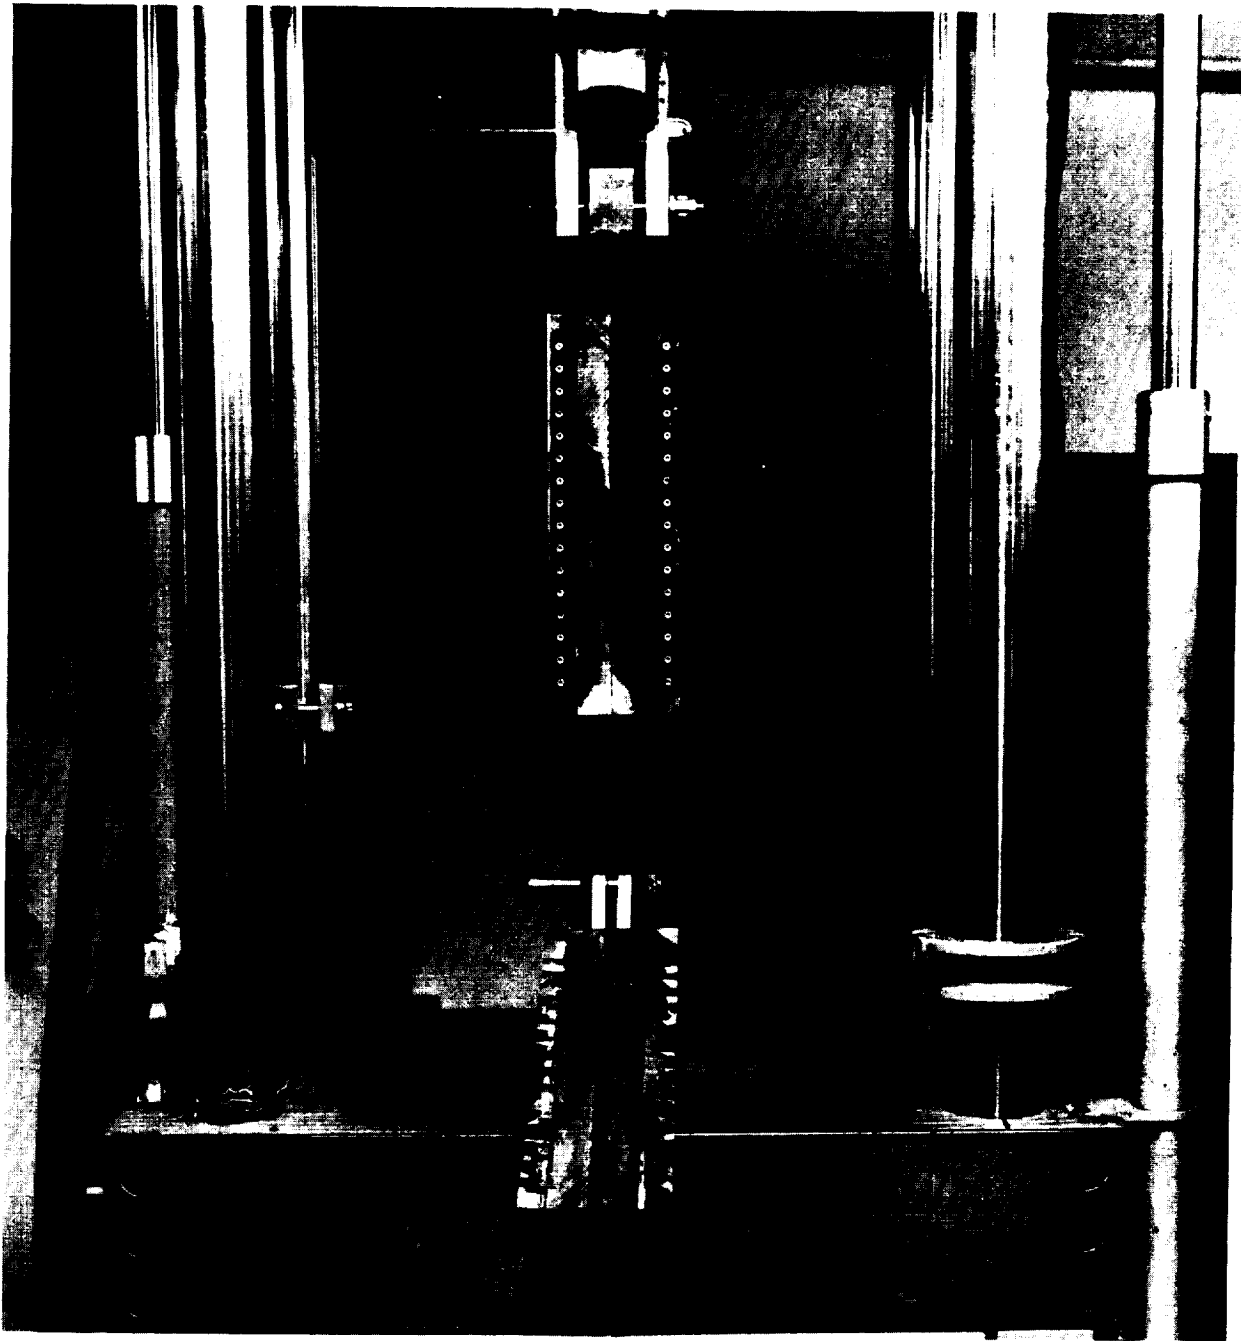
Figure 4-29: Failure of fail-safe specimen.

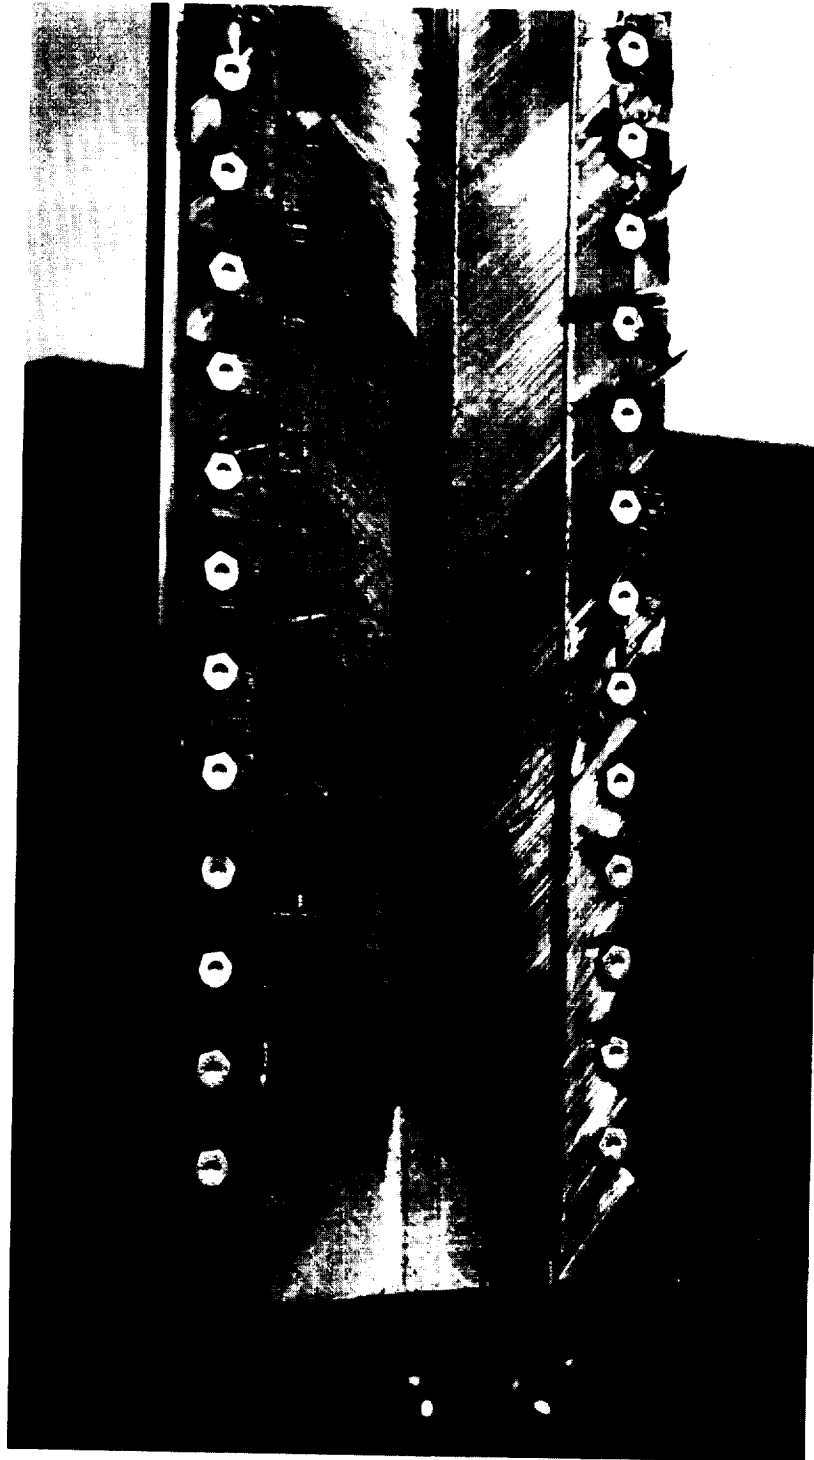
Figure 4-31: Closeup of skin side of failed fail-safe specimens.

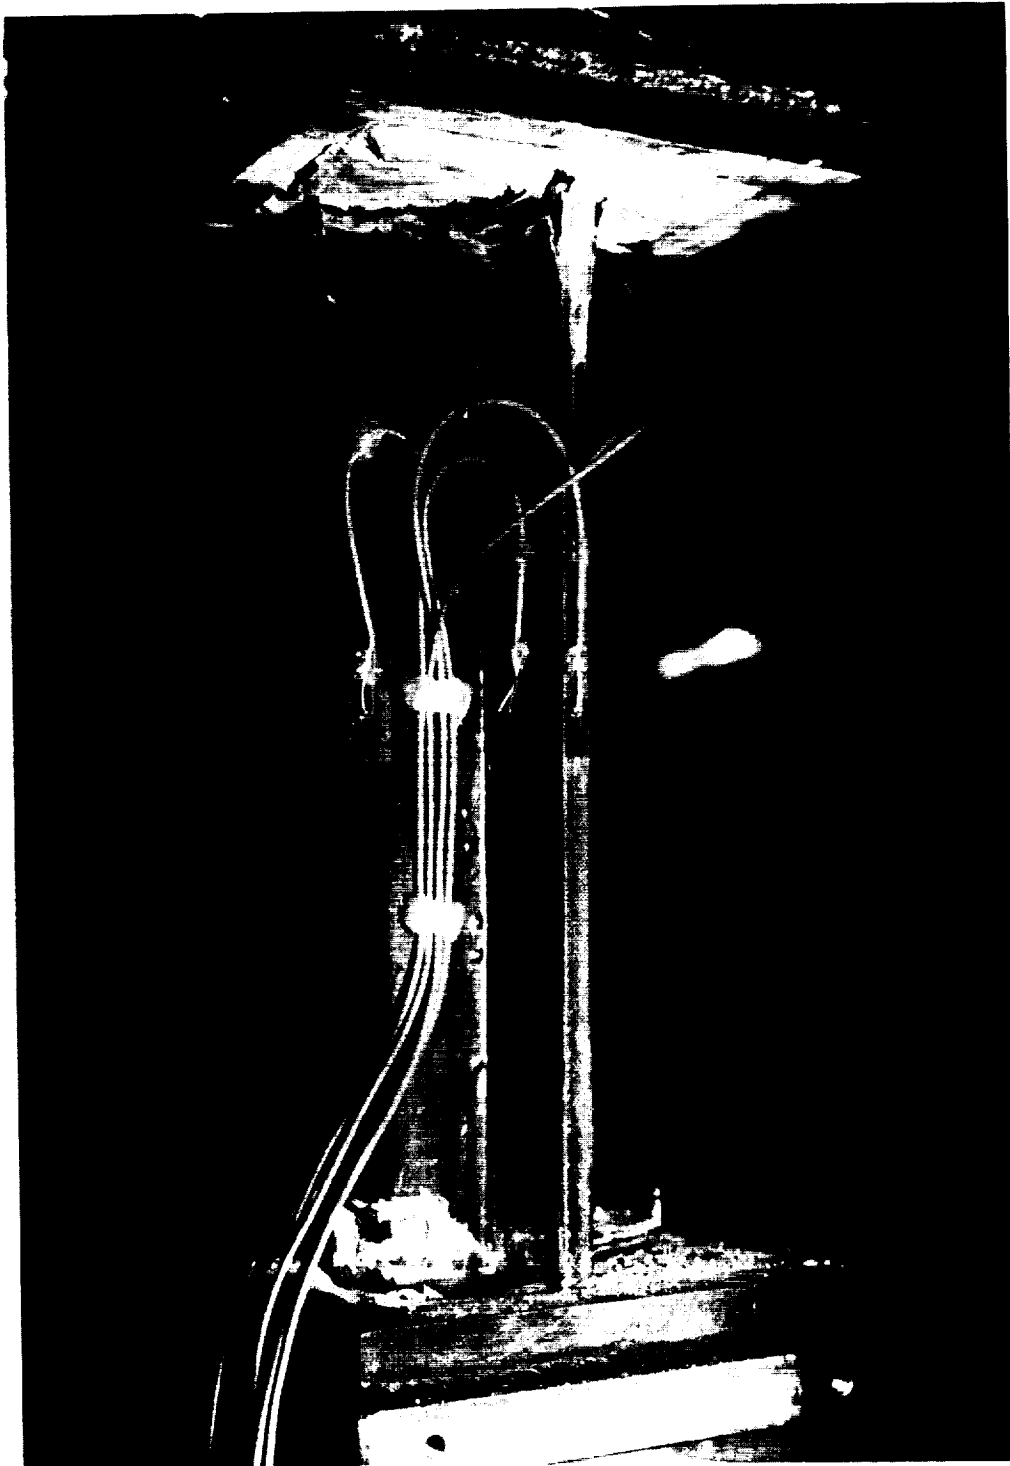
Figure 4-39: Overall view of failed stiffened Panel A.

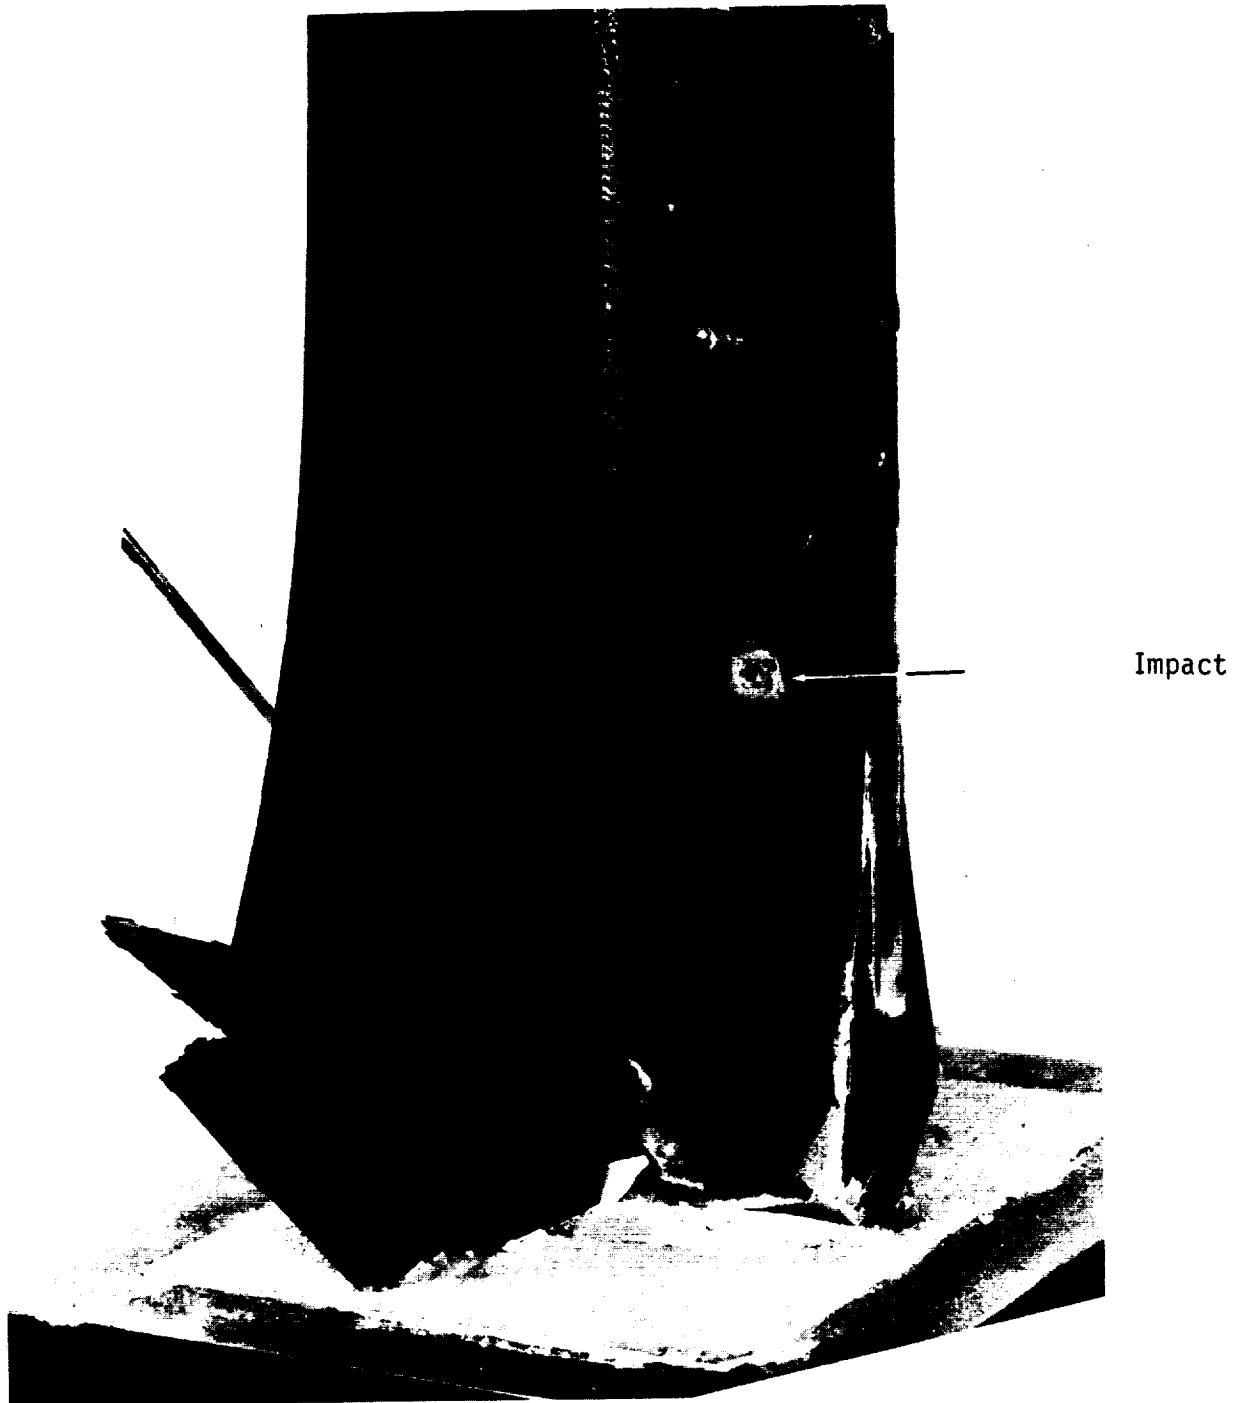
Figure 4-56: View of skin and stiffener of failure of retest of impacted stiffener. Location of impact is shown.

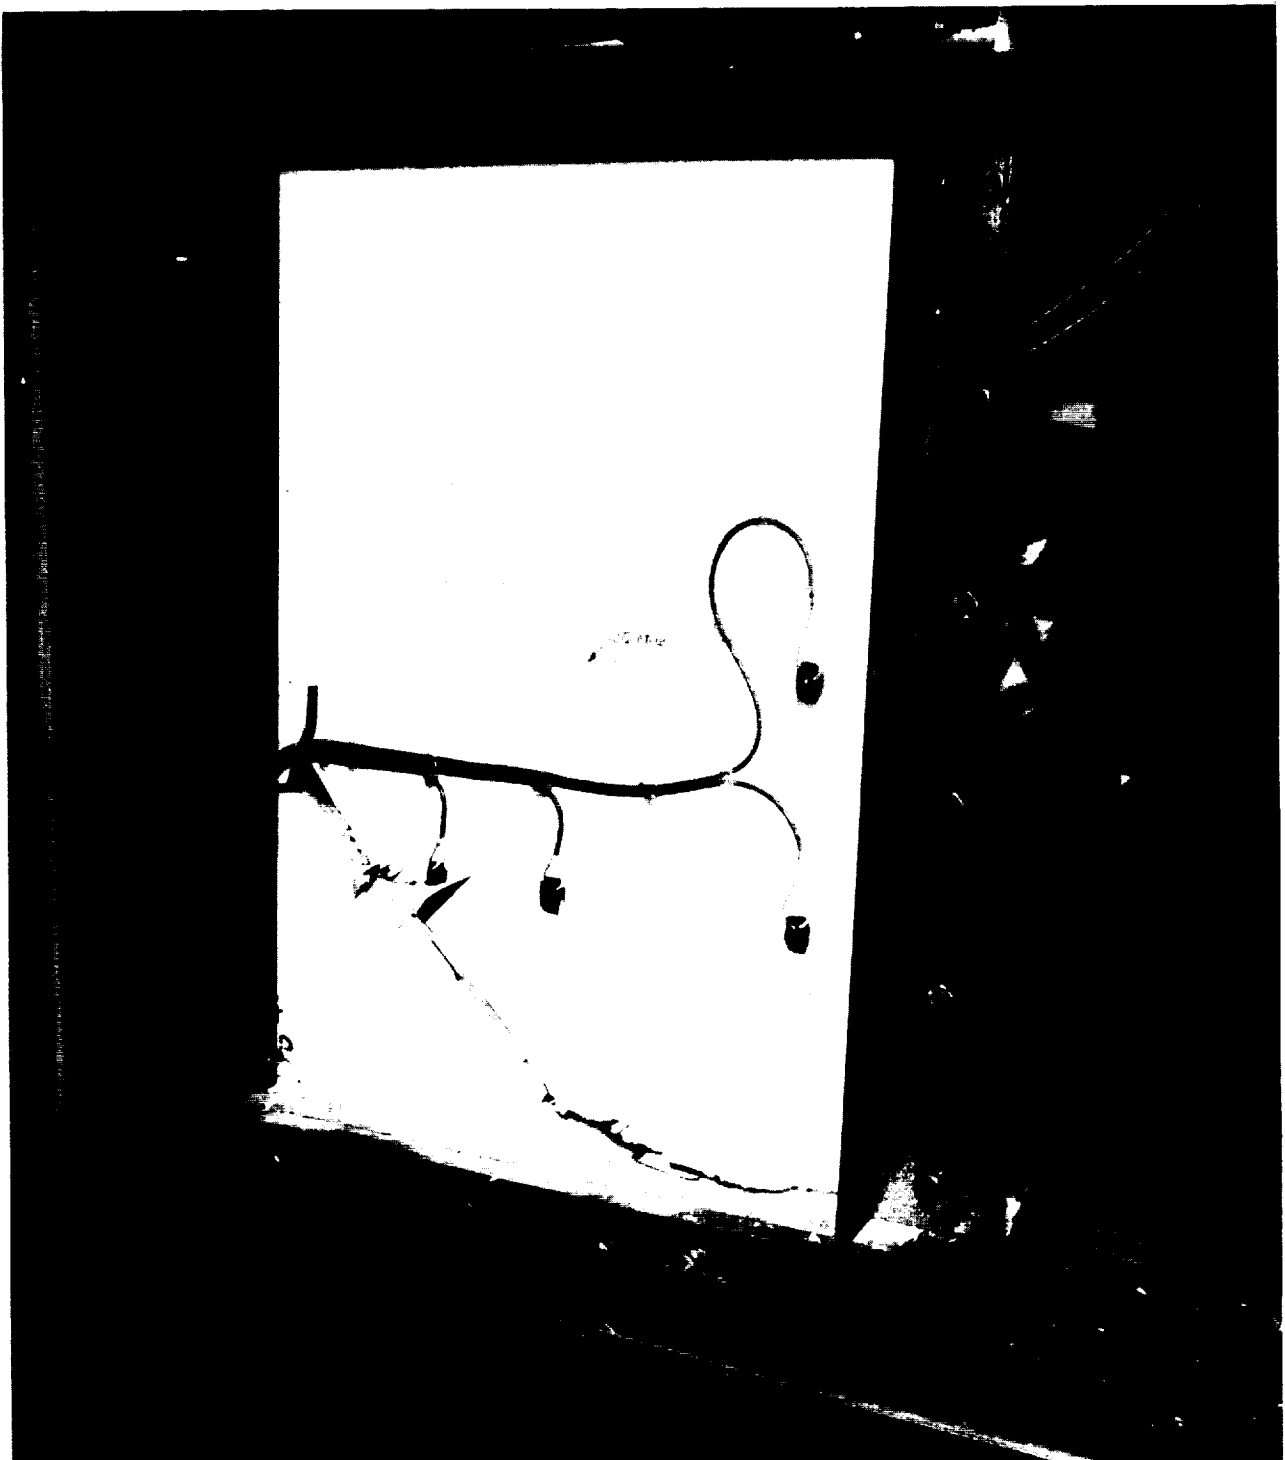
Figure 4-63: Front side of failed impacted stiffened panel. Photo No. 149751R

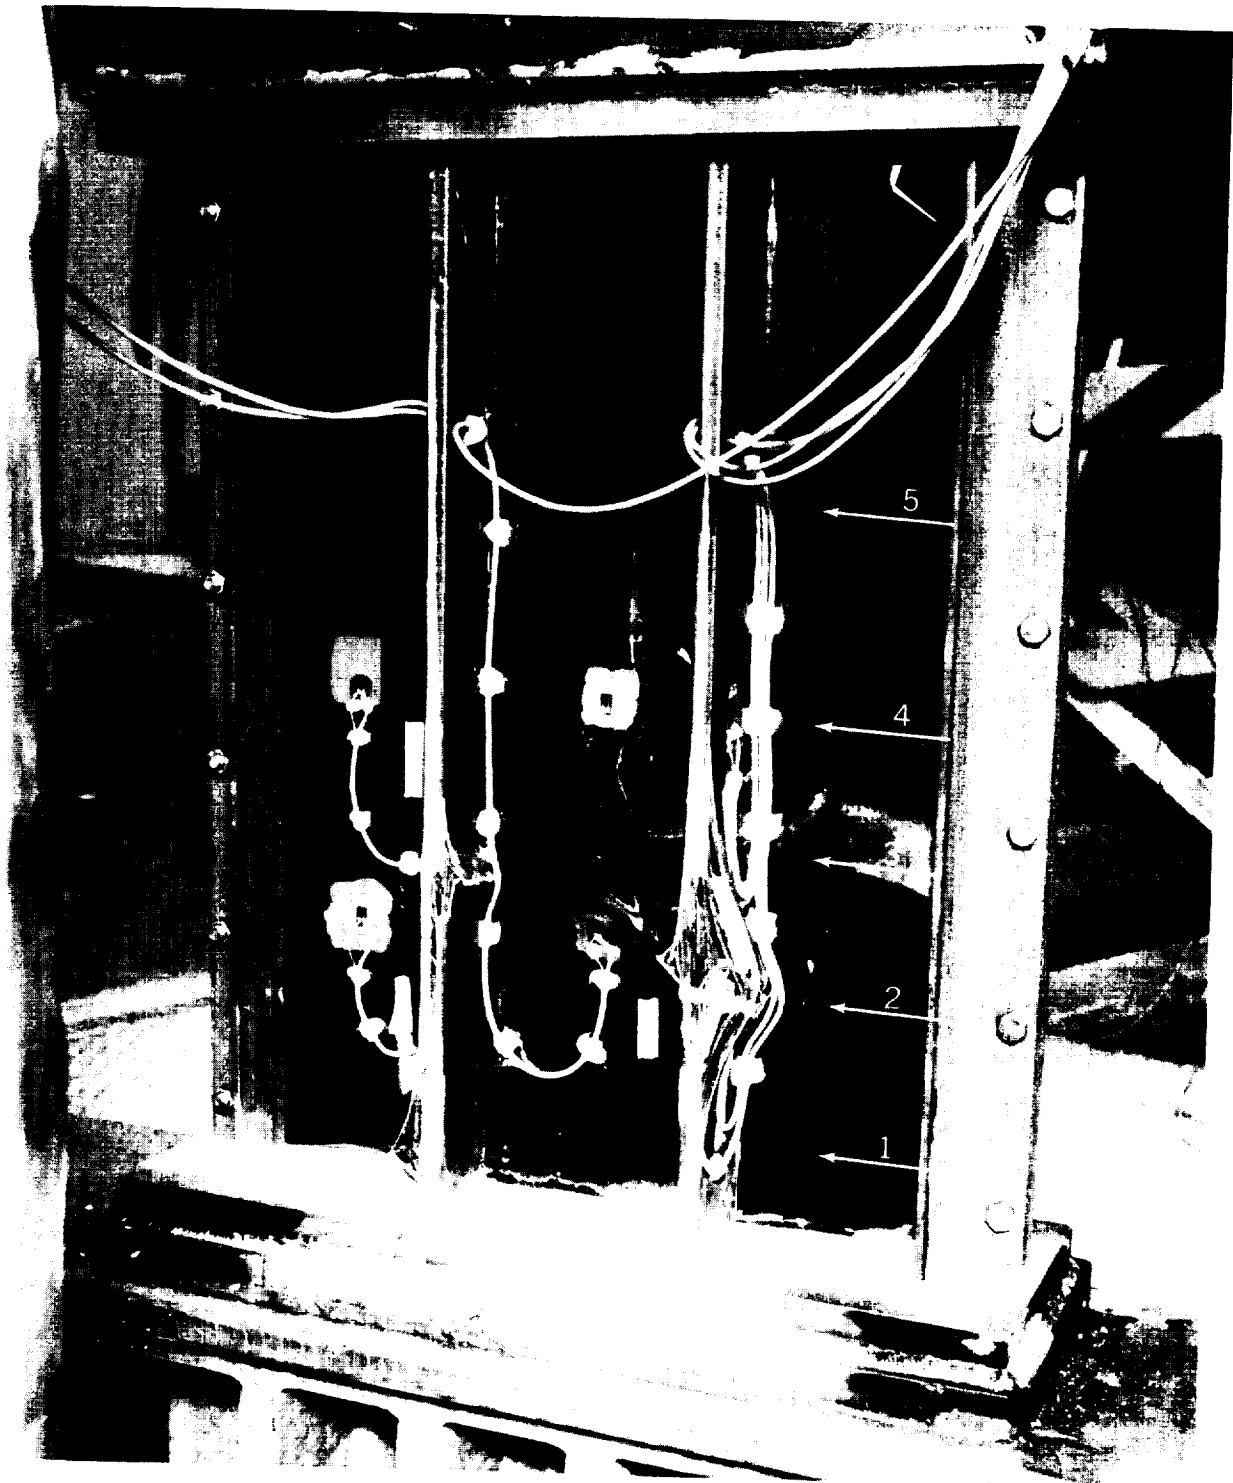
Figure 4-64: Back side of failed impacted stiffened panel. White arrows indicate section plane.

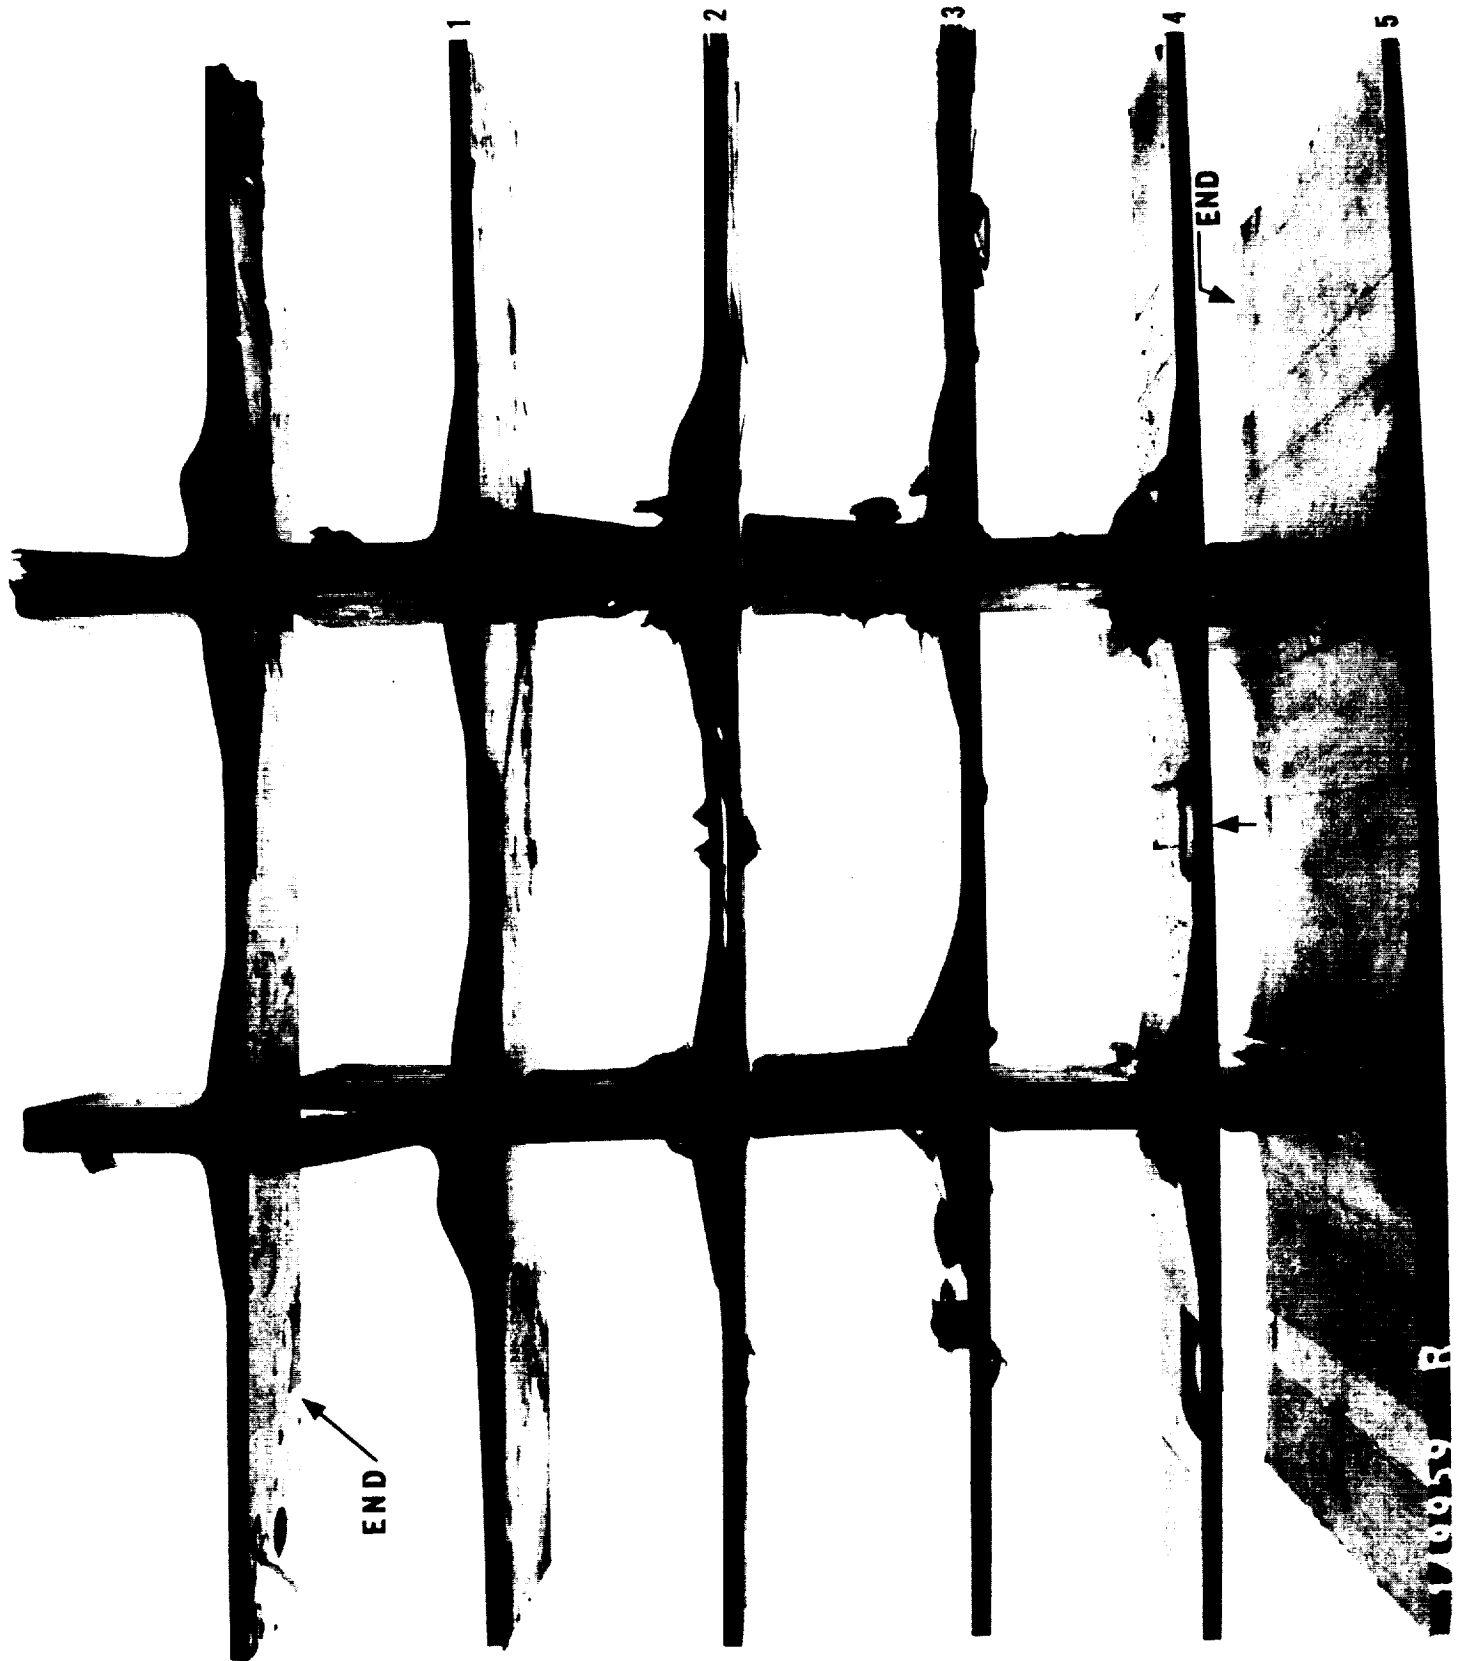
Figure 4-67: Sections of failed impacted panel. Arrow indicates impact site. Locations are shown in Figure 64.
